Pansat 3500SD C13 - C14 Capacitor Replacement Guide

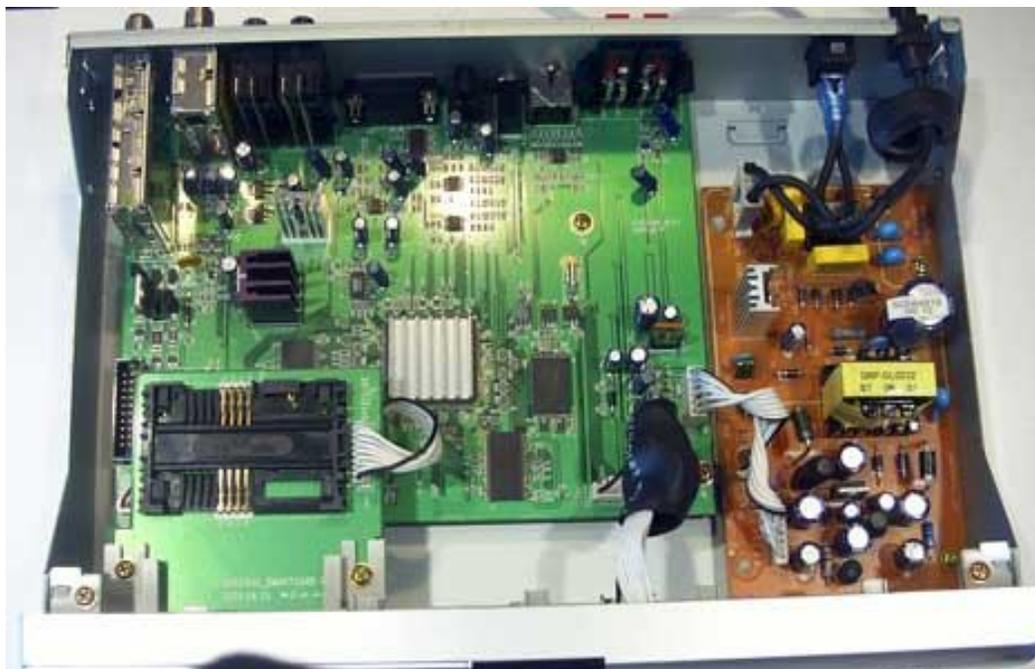
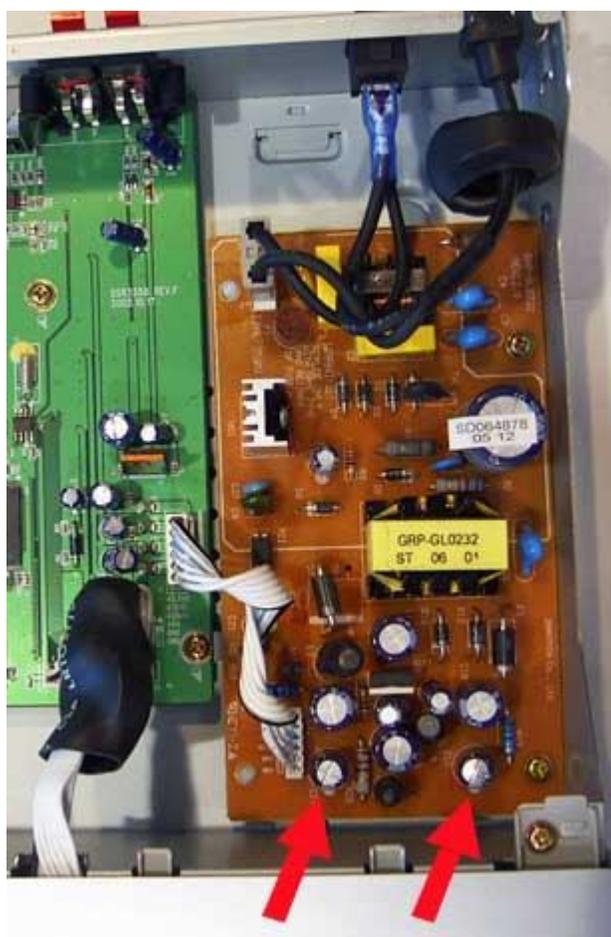
With the cover removed this is how your receiver looks inside:

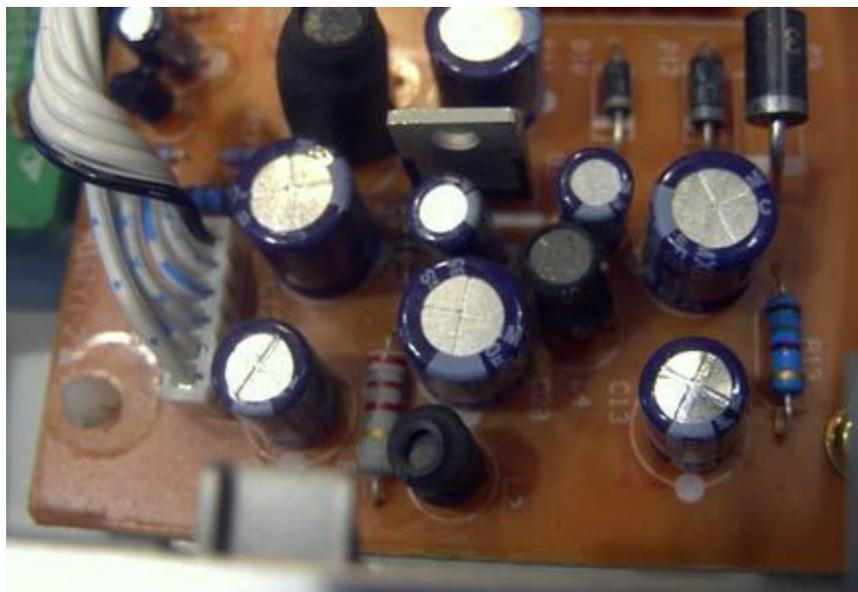
Here is the area you are looking for, the red arrows point to C13 (right) and C14 (left)

You should look for outward signs of a blown capacitor, while a bad cap may not always show signs they usually do. In this case C13 (right side of picture) was the culprit. Look at the tops of all the other caps and you can see they are all FLAT. Now look at C13, it has clearly swelled up and the top is visibly “domed” upward. Also look for signs or leakage, brown spots on the cap or the board.

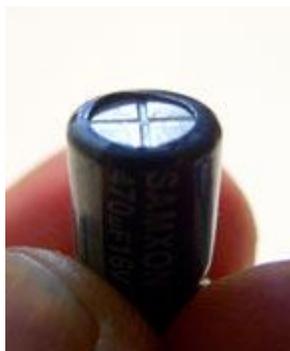
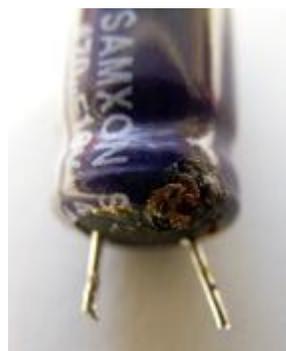
I will jump ahead just a little here so you can get a good idea of what to look for. These are the two caps that were removed; on the left is C14 with the normal “flat” top. In the center is C13 with its swollen and “domed” top. Even though there were no signs of leakage at first, once removed you can see that the bottom of the capacitor was indeed leaking. (Picture on the right)

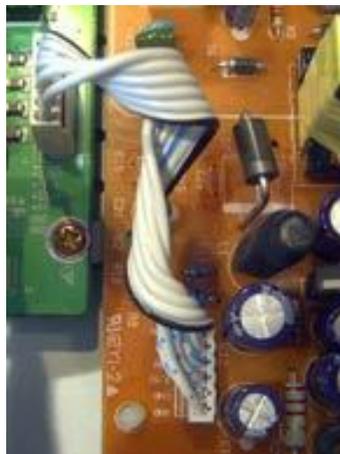
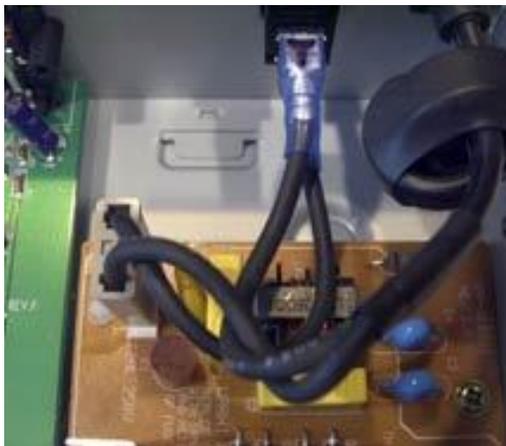
Ok, back to removal and repair. The next thing to do is disconnect three connections. First is the ribbon cable at bottom left, it disconnects from the side that is attached to the larger “green” board. Next is the two power connections, one at the top of the board and the other at the switch at the rear of the chassis.

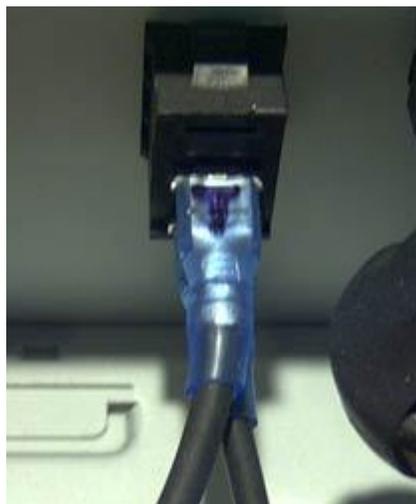
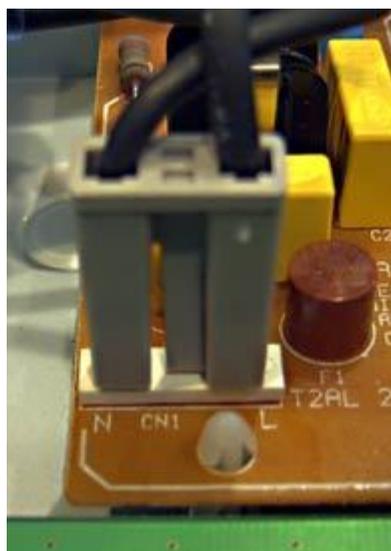
I like to reconnect things the same way they were originally connected so I used a felt tip pen to mark a letter “T” on the top wire connection to the switch. (Left picture) The power plug already had a white dot on one side so I made a mental note of it. (Right picture)
Note, the ribbon cable connector is keyed and will only go back on one way.

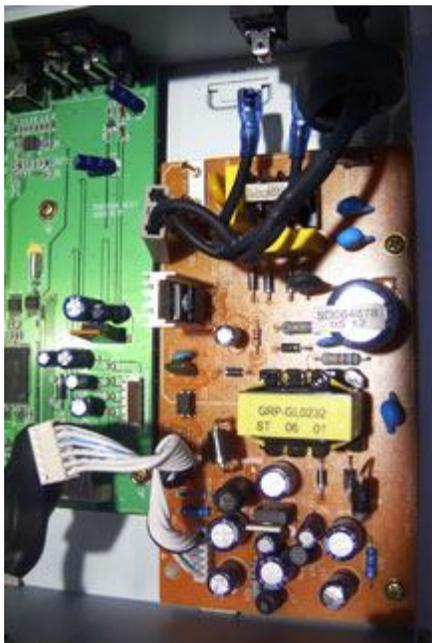
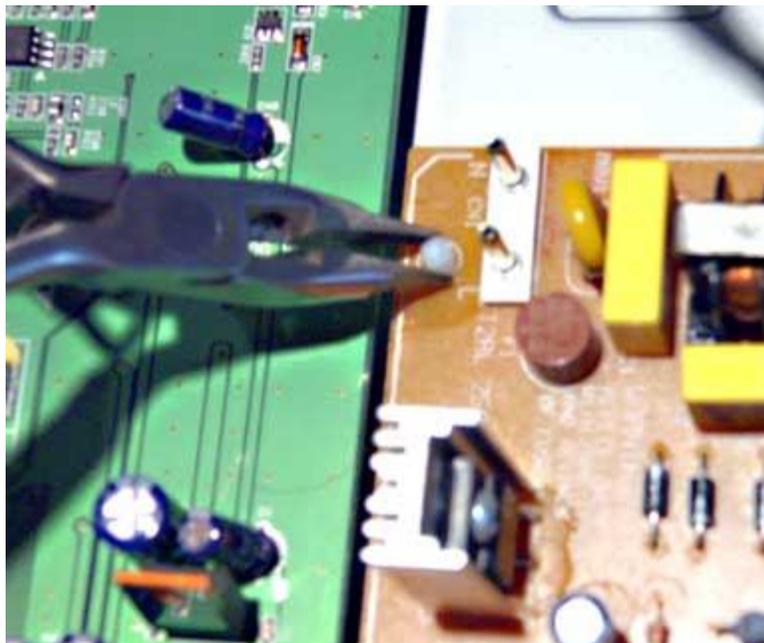
After making all the disconnects remove the two screws on the right side of the board. The left side of the board is mounted on plastic stand-offs that have flexible “wings” at the top. I use needle nose pliers to hold these wings together so that I can lift the board off the stand-off.

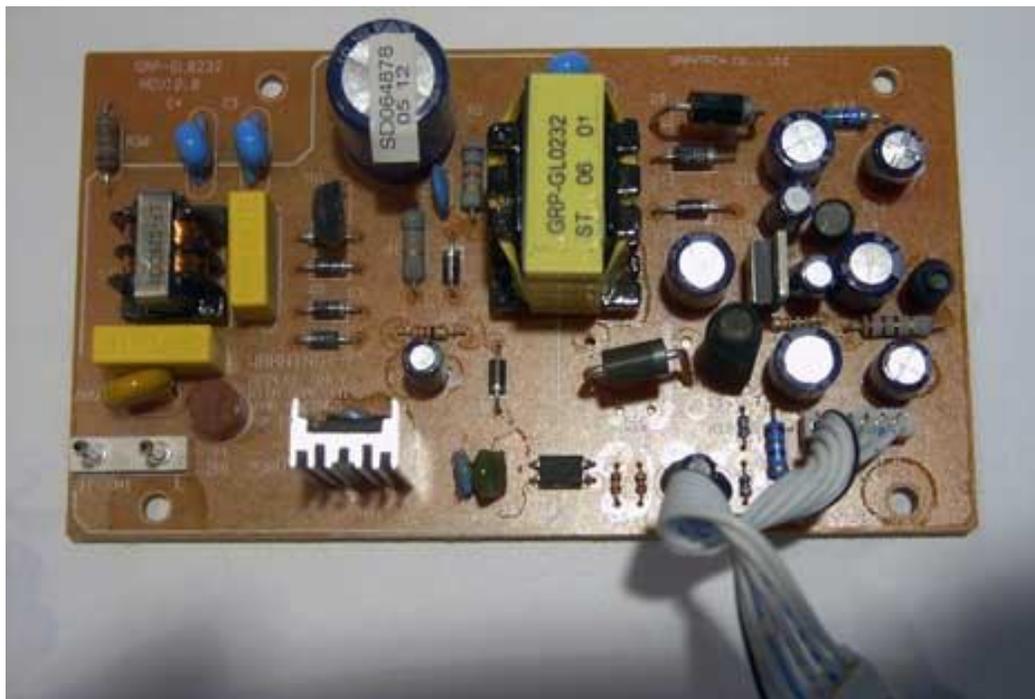
Here is what you have once the board is lifted out of your STB.

Pay attention to the orientation to the capacitors before removal. These capacitors are polarized, one side is marked (-) or minus, is usually striped on that side also. Be careful to put the new capacitors in the same way as the originals. Polarity is also marked on the board, with the negative position indicated by a white dot.

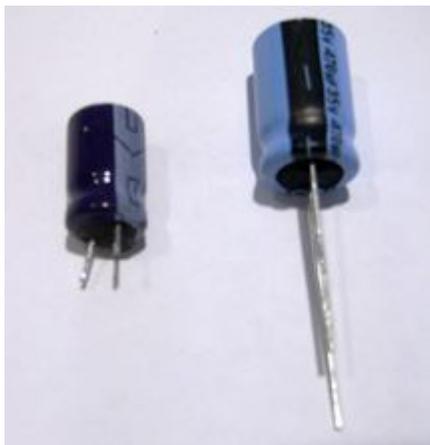
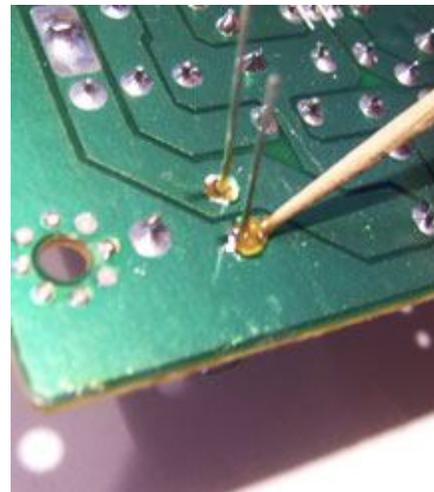
Below, on the left, is the removed, existing capacitor and the replacement 470uf/35V capacitor. The “can” of the 470uf/35V capacitor is larger because of the increased voltage handling capacity. (35V) The legs are the same spacing and there is plenty of room so the caps fit fine.

Making sure the alignment is correct, push the legs of the capacitor through the holes and hold the capacitor flat against the board. In the picture on the right solder paste (flux) is being applied on the legs at the solder points. An alternate method is to simply dip the tip of your solder into the paste. This step can be omitted but the paste makes the solder flow evenly into the area being soldered and adhere better to the surfaces.

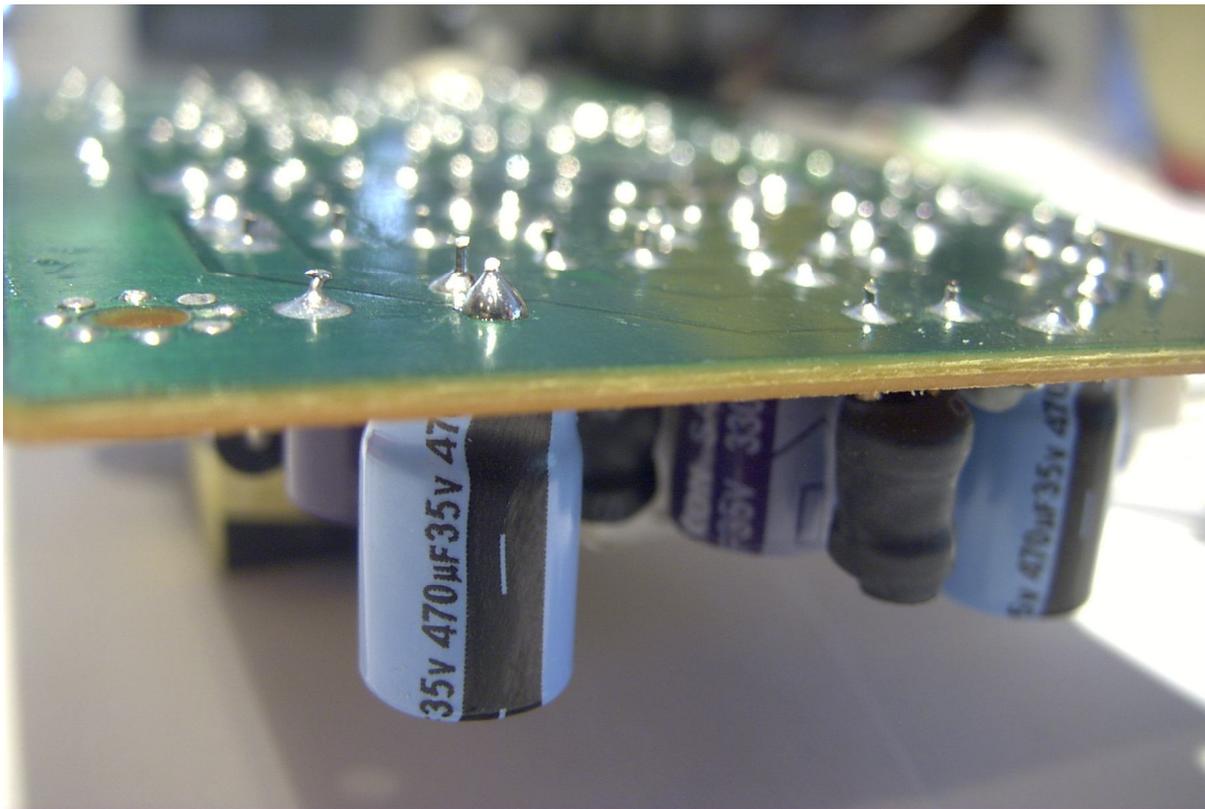
Here is your finished product as seen from the solder side.

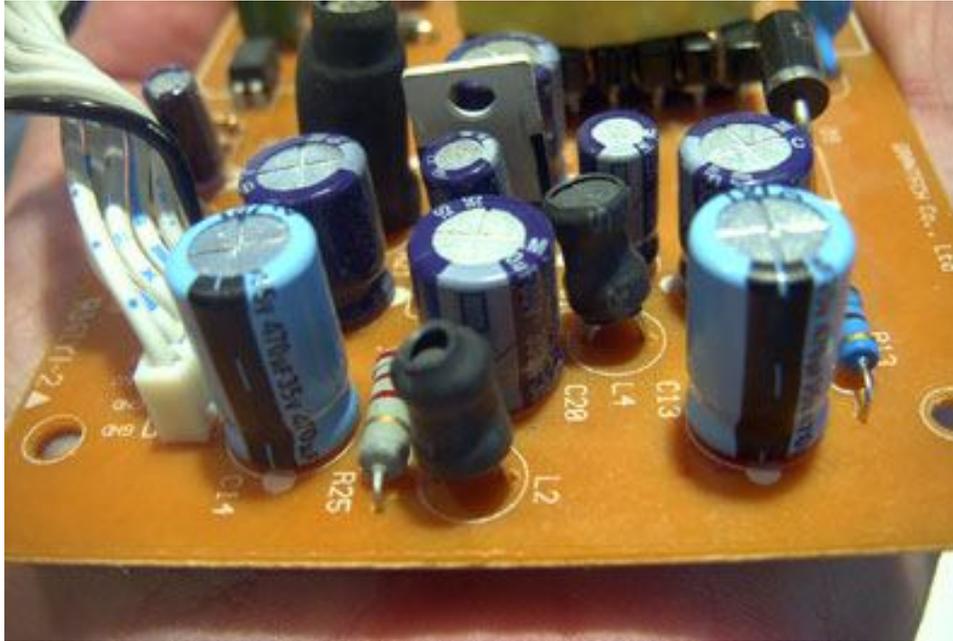
Here is the finished board as seen from the component side. Notice the striped, minus side of the capacitors is aligned with the white dot on the board.
